REPORT ON THICKNESS MEASUREMENT

Ship's Name: XIN BIN HAI

TM Report Number: ZSN2066110

Ship Particulars			
Flag	: PANAMA	Port of Registry	: PANAMA
ESP Ship	: Yes	Ship Type	: Single Skin Bulk Carrier
Rule Length [m]	: 294.47	Gross Tons	: 94,863
Deadweight (t)	: 180,085.7	Date of Build	: 22 March 2010

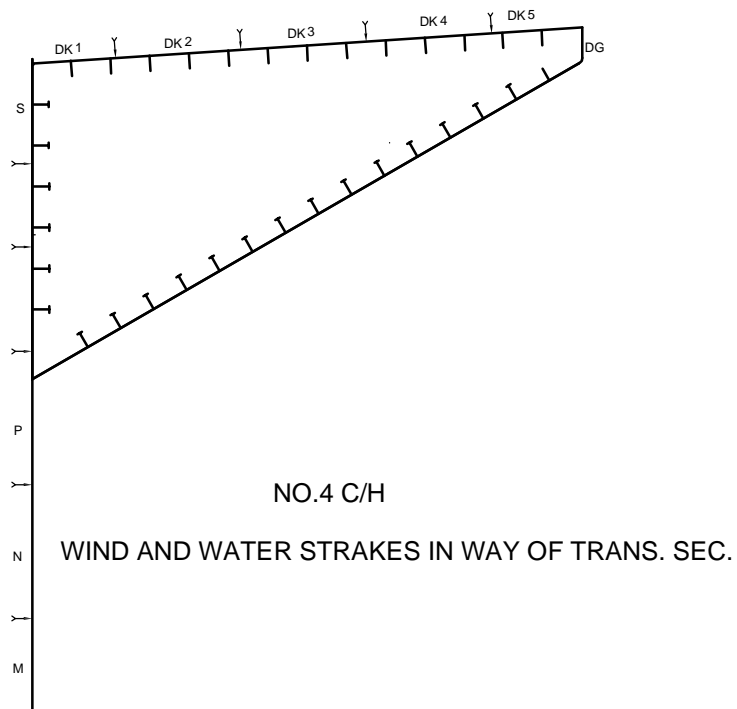
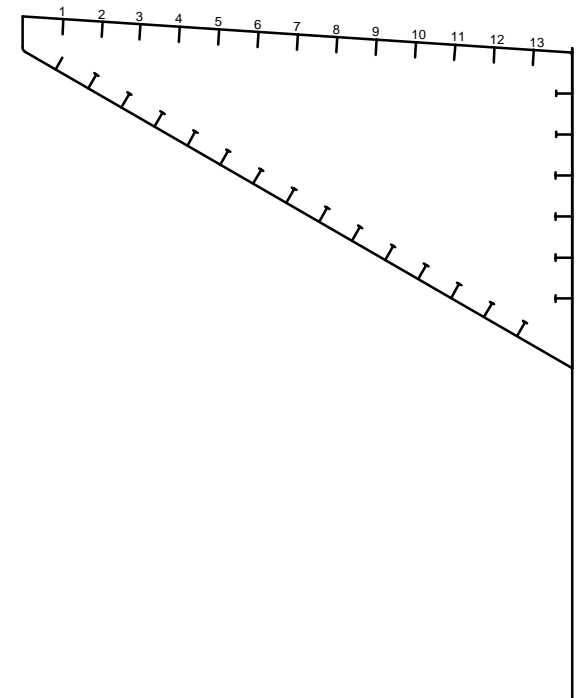
FR. 199/200

Transverse Section :		No. 1											
Zone :		Deck Zone											
Frame No. :		Frame No. 199/200											
Tank / Compartment / Space	Structural Component	Sketch Reference ID	As Built Thickness (mm)	Voluntary Thickness Addition (mm)	Renewal Thickness (mm)	Plate / Profile / Width / Height (mm)	Port Reading			Starboard Reading			Comments
							Gauged Thickness (mm)	Remaining Corrosion Addition (mm)	Thickness As Renewed (mm)	Gauged Thickness (mm)	Remaining Corrosion Addition (mm)	Thickness As Renewed (mm)	
NO.4 T.S.T	MAIN DECK	DK1	32	0	28		31.6	3.6		31.3	3.3		
NO.4 T.S.T	MAIN DECK	DK2	32	0	28		31.5	3.5		31.2	3.2		
NO.4 T.S.T	MAIN DECK	DK3	32	0	28		31.3	3.3		31.4	3.4		
NO.4 T.S.T	MAIN DECK	DK4	32	0	28		31.5	3.5		31.5	3.5		
NO.4 T.S.T	MAIN DECK	DK5	32	0	28		31.2	3.2		31.3	3.3		
NO.4 T.S.T	DECK LONGL.	1	32	0	28		31.7	3.7		31.8	3.8		
NO.4 T.S.T	DECK LONGL.	2	32	0	28		31.8	3.8		31.7	3.7		
NO.4 T.S.T	DECK LONGL.	3	32	0	28		31.6	3.6		31.9	3.9

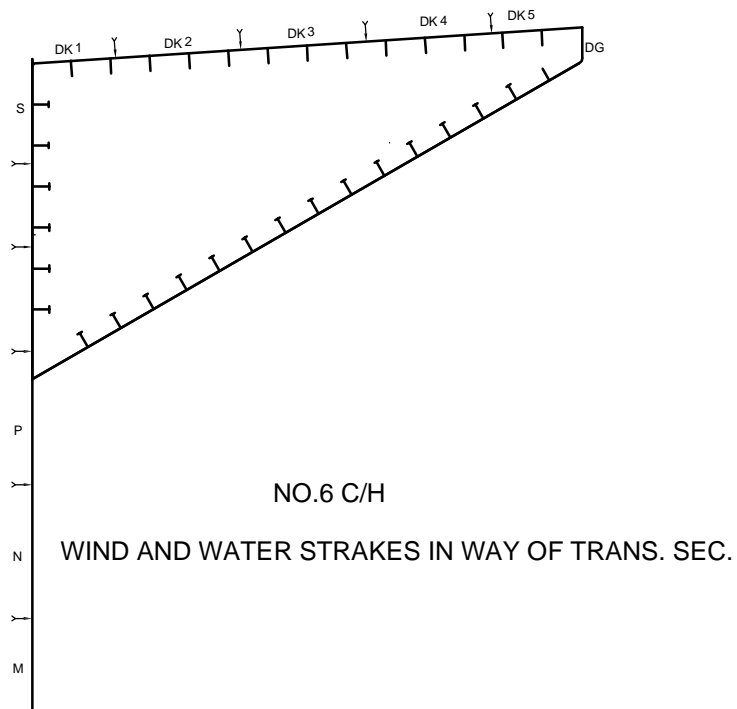
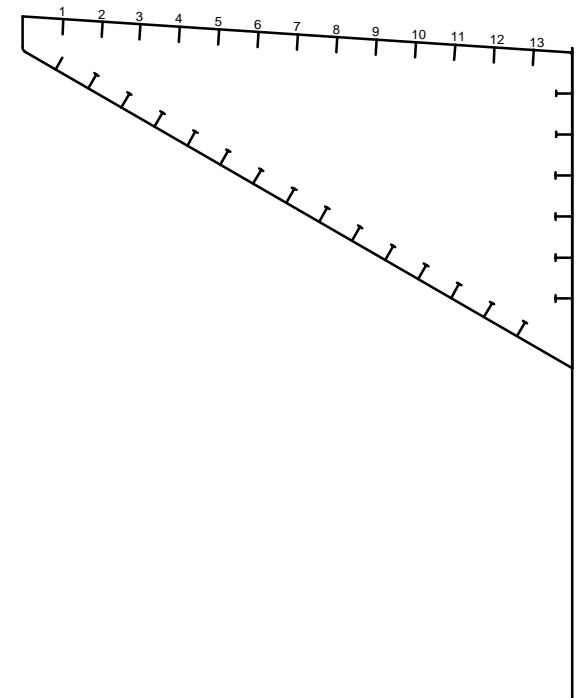
FR. 151/152

Transverse Section :		No. 2											
Zone :		Deck Zone											
Frame No. :		Frame No. 151/152											
Tank / Compartment / Space	Structural Component	Sketch Reference ID	As Built Thickness (mm)	Voluntary Thickness Addition (mm)	Renewal Thickness (mm)	Plate / Profile / Width / Height (mm)	Port Reading			Starboard Reading			Comments
							Gauged Thickness (mm)	Remaining Corrosion Addition (mm)	Thickness As Renewed (mm)	Gauged Thickness (mm)	Remaining Corrosion Addition (mm)	Thickness As Renewed (mm)	
NO.6 T.S.T	MAIN DECK	DK1	34	0	30		33.1	3.1		33.5	3.5		
NO.6 T.S.T	MAIN DECK	DK2	34	0	30		33.3	3.3		33.4	3.4		
NO.6 T.S.T	MAIN DECK	DK3	34	0	30		33.4	3.4		33.6	3.6		
NO.6 T.S.T	MAIN DECK	DK4	34	0	30		33.5	3.5		33.3	3.3		
NO.6 T.S.T	MAIN DECK	DK5	34	0	30		33.2	3.2		33.4	3.4		
NO.6 T.S.T	DECK LONGL.	1	32	0	28		31.6	3.6		31.8	3.8		
NO.6 T.S.T	DECK LONGL.	2	32	0	28		31.9	3.9		31.8	3.8		
NO.6 T.S.T	DECK LONGL.	3	32	0	28		31.8	3.8		31.9	3.9
